1 Supplementary material

2 **The impact of coal ash and slag dump on the quality of surface and ground waters – a case**
3 **study**

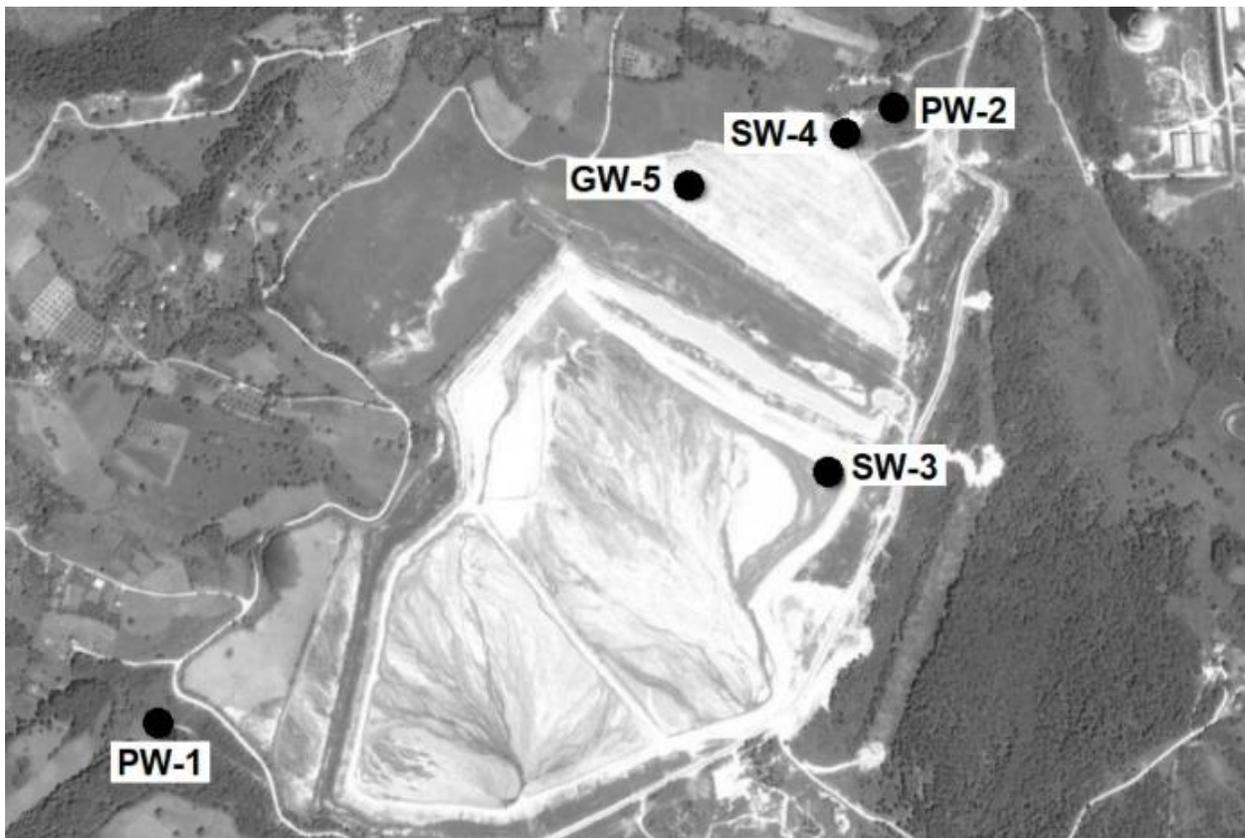
12 Fig S-1. Map showing sampling points: PW-1 Water sampling from Paleški Creek, upstream of the dump,
13 PW-2 Water sampling from Paleški Creek, downstream of the dump, SW-3 Surface water sampling from
14 the dump, SW-4 Water sampling from the borehole 4 (5 m depth) GW-5 Water sampling from the borehole
15 5, (21 m depth)
